## *Conjet Robot assists with Guri Dam spillway repairs*

## The Guri Hydroelectric Power Station - providing 70 % of Venezuela's electricity

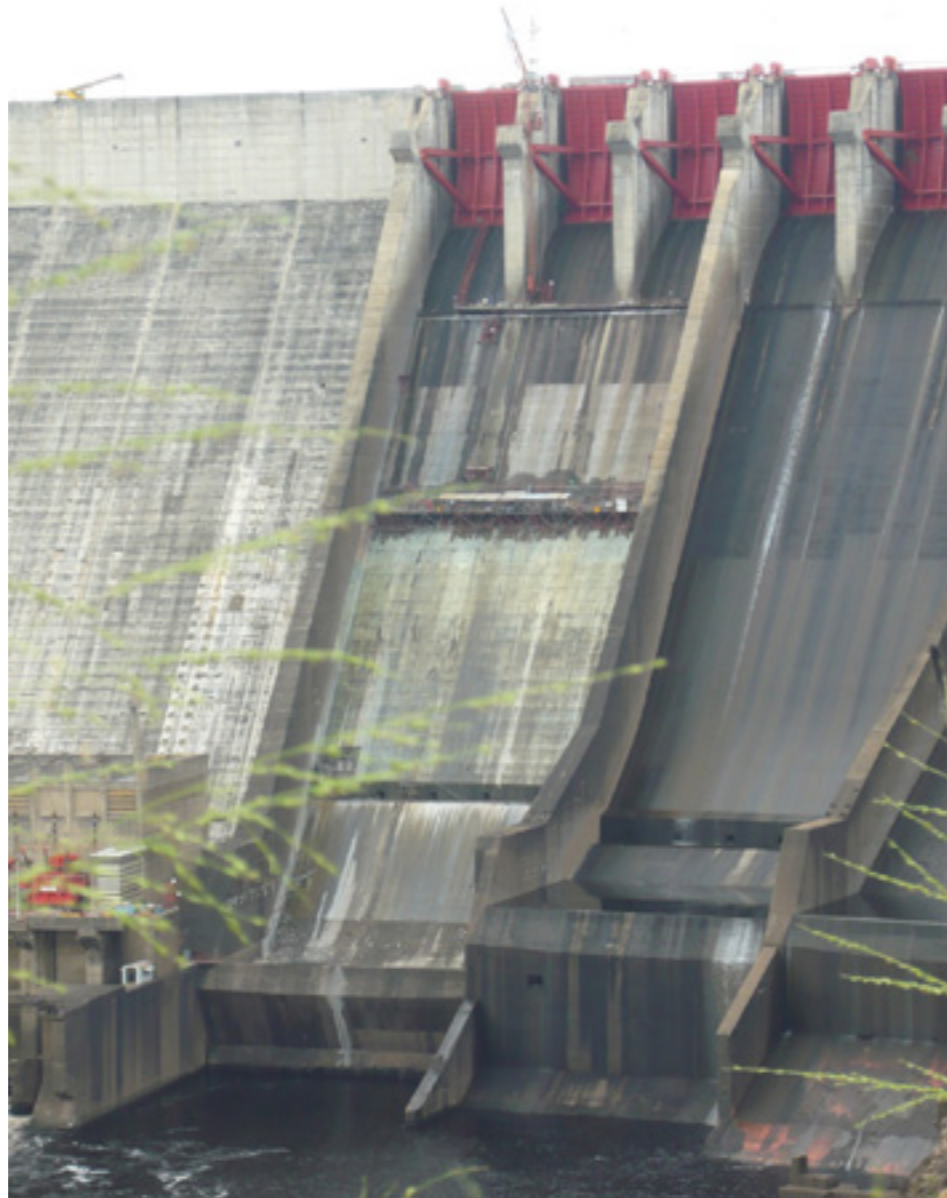
The surfaces on parts of the spillway needed repairing and the Venezuelan government's power station owner and operator, Corporación Eléctrica Nacional, awarded a contract for the spillway renovation to the local general and civil engineering contractor Fapco C.A. based in Puerto Ordaz, Bolívar. The dam spillways have been in operation

for over 30 years and the force of the fast flowing water and continuous exposure to the sun light and the environment have combined to erode the surface with caving and loosening of the concrete.

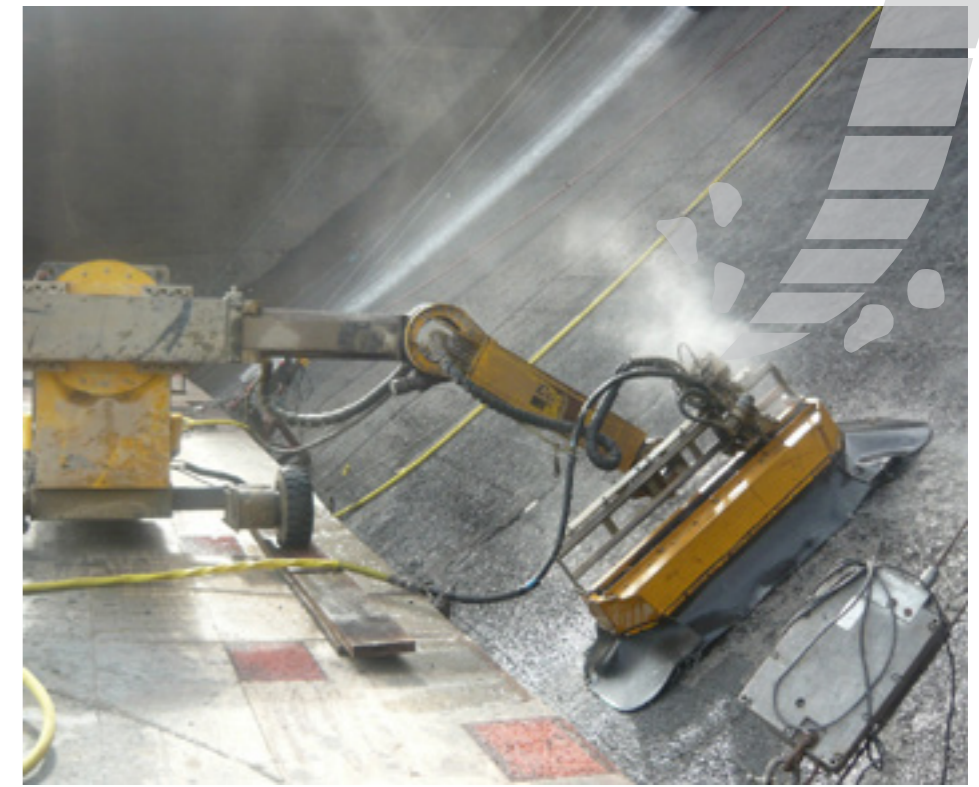
Fapco had to completely repair one channel and perform partial repairs to another, covering a total area of about 7,500 m<sup>2</sup>. The Robot 364, operating at water pressures up to 1200 bar, selectively removed the weakened and damaged concrete from the spillway surfaces to depths ranging from 20 mm to 150 mm and in some instances exposing the steel reinforcement. Concrete removal was up to 69 m<sup>2</sup>/day and was intermittent due to a combination

of moving the platform, adjusting the Robot to the spillway geometry and refilling the water tank supplying the Robot. After concrete removal Fapco followed on with a spray applied 800 kN/m<sup>2</sup> strength mortar in areas less than 100 mm deep and 500 kN/m<sup>2</sup> strength concrete in the deeper areas.
