Hydrodemolition for Skanstull Bridge repairs

Conjet technology gains approval from the city's Traffic and Property Management department

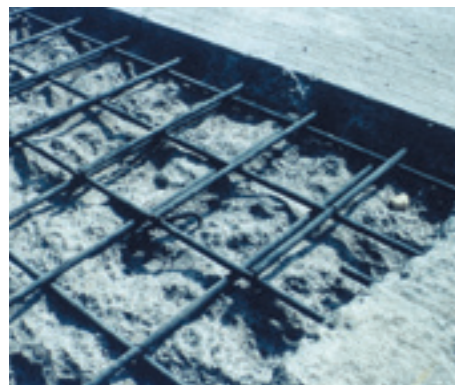
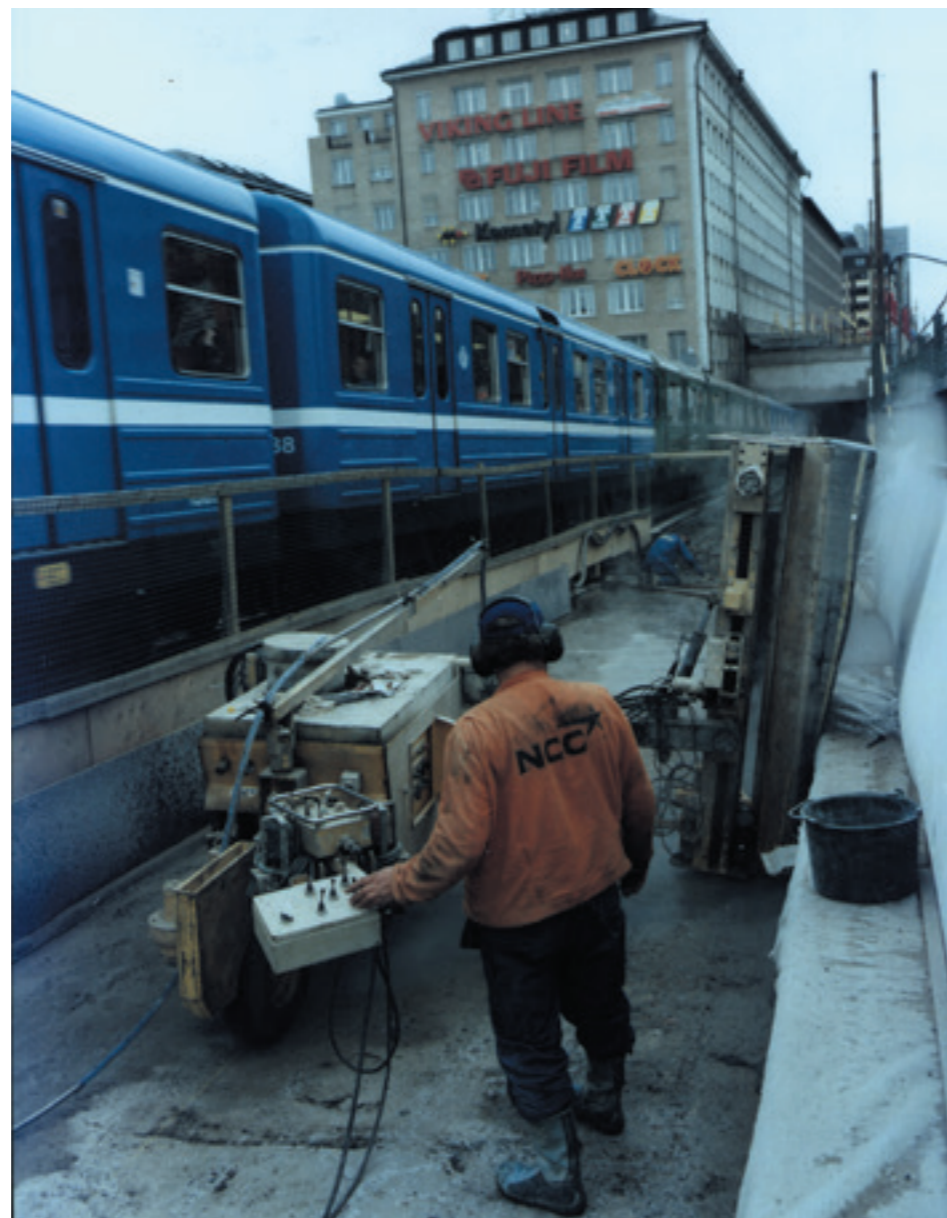
Vertical boom and rotor

The specialist hydrodemolition contractor NCC Waterjet used two Conjet Robots each with a Conjet 380 Hp Power Pack. One Robot was fitted with a vertical feed beam for removing concrete from the side beam faces. The other Robot was initially equipped with a hydraulic rotor to take off the deck's bitumen sealant. The rotor was then replaced with a standard horizontal feed beam and oscillating nozzle to remove the deck's top 20 mm thick layer of concrete. NCC Waterjet completed the job well within the contract period and to a very high standard. Site personnel agreed that nothing but hydrodemolition could have done the job so fast and so well. As hydrodemolition had proved such a success on the deck and side beam faces the bridge owner decided to test, evaluate and compare

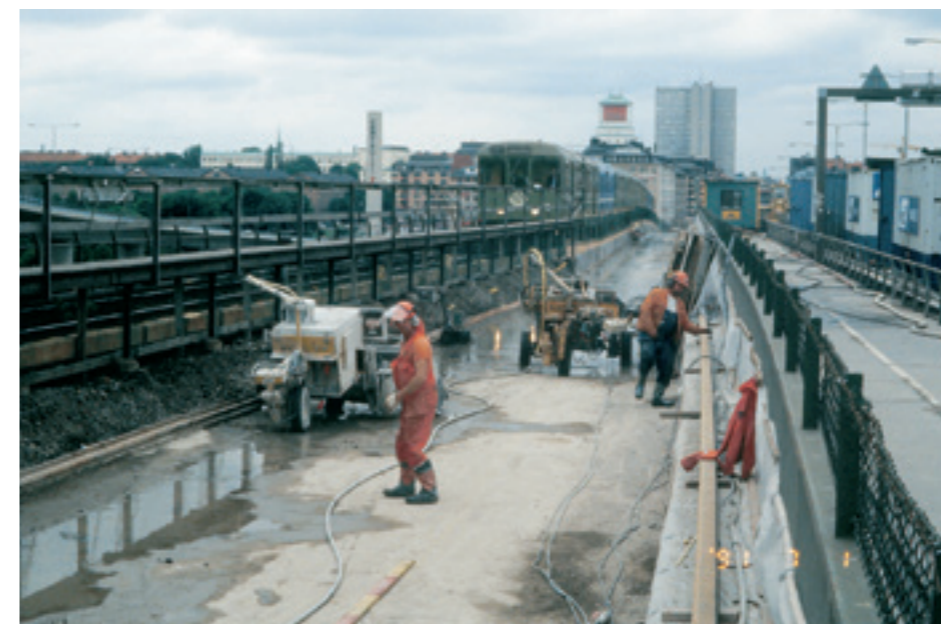
In addition a special rig fitted with protective sheeting prevented water spray and concrete debris from the subway trains running 200 mm from the hydrodemolition operation. The modified Conjet Robot removed a 70 mm thick strip from the top of

the sidebeam leaving a rough, uneven textured surface to accept the fresh concrete. Formwork was erected, reinforcement added and new concrete placed to a depth of 200 mm to complete the sidebeam repair and strengthening.

The experience gained from the comparative tests on the eastern side of the bridge led Gatu- och Fastighetskontoret to adopt hydrodemolition as the only solution to obtain a technically acceptable repair for the western side beam. But access to the side beam, which was very close to the adjacent subway track, was severely restricted. Trains could not be stopped during the bridge repairs and the only solution was to modify the Conjet Robot to travel along the top of the beam. Conjet narrowed the Robot's base frame and shortened the feedbeam to match the width of the parapet. In addition NCC Waterjet fitted the Robot with accurate guidance devices to keep the machine correctly positioned.
