Conjet to Rescue in California Tunnel Fire Repairs

Damage inspections

Case Stories

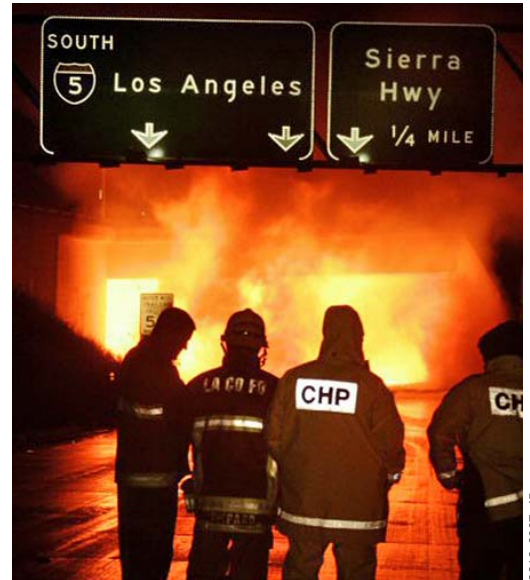
Massive fire in the Tunnel on the I-5 golden State Freeway in California

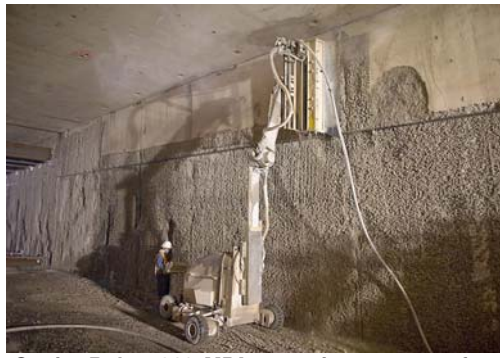
3312 8007 47

Conjet Robot 363 MPA removing concrete from the Tunnel wall

nozzle with a narrow fan jet pattern instead of the normal straight jetting nozzle. This was great, especially in those areas where they just wanted to roughen up the existing concrete surface to get a bond for the new overlay.”

From the initial tests Caltrans opted to remove concrete from the entire area of both walls, equivalent to about 30,180ft² (2,803m²) on the walls of the tunnel and an additional 2,600ft² (242m²) on the wing walls. In the undamaged areas removal depth varied from about 0.5in to 1.25in (25mm to 31.25mm) and in the damaged areas the removal was from 2in to 4in. (50mm to 100mm) and in some isolated spots it was up to a maximum of 6in (150mm). “The day after testing we started on the main removal, which overlapped and extended from the initial emergency repair cleanup contract under Chumo Construction with the main repair contract under prime contractor Security Paving,” adds Paul Phelps. “To complement our Conjet 322 for the project we brought in a larger Conjet 363 Robot and 500hp (373kW) Hammelmann HDP-353 pump capable of 32 gpm

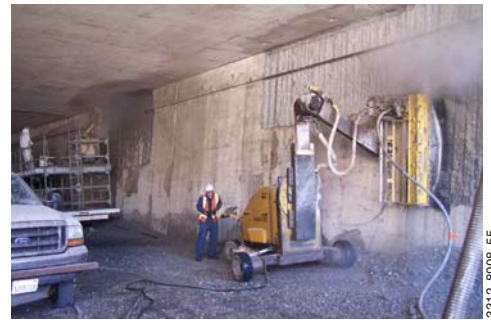
3312 8008 55

Conjet Robot 363 MPA and Conjet Robot 322 on a scaffold in the background removing concrete from the tunnel wall.

(121litres/min) at 21,000psi (1,428bar) from Conjet’s US agent National Hydro, based in Fowlerville, Michigan. Using the fan jet nozzle on the Conjet 363 Robot we were able to prepare 730ft²/h, (68m²/h) equivalent to concrete removal of 1.7yd³/hphour (1.3m³/hphour). In the initial emergency repair contract with Chumo we removed about 6,400ft² (595m²). But in our contract with Security Paving we had about 26,400ft² (2,452m²) of surface preparation and concrete removal on the tunnel walls, which we did amazingly fast. Working two 12 hour shifts we were finished in just four days and there is no way we could have done that in that time without the Conjet 322 and 363 Robots.”
