Conjet assists in World's most extensive concrete bridge repairs

6,320 m long multi-span bridge

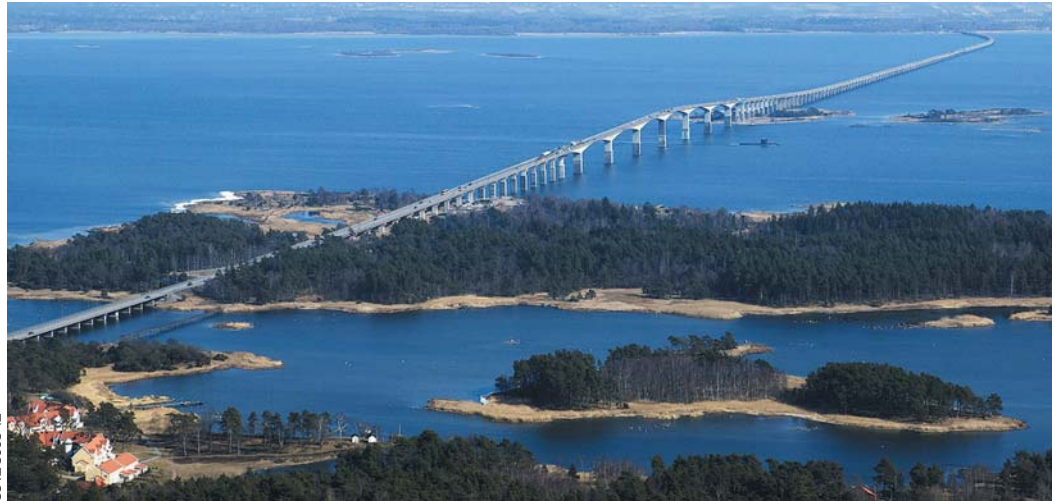
A Conjet Robot 363 MPA high pressure water jetting hydrodemolition machines played a key role assisting in repairs to the bridge deck. Contractor Waterjet Entreprenad AB, worked as the specialist hydrodemolition contractor for NCC, were using its Conjet Robot 363MPA, to selectively remove concrete from the edge of the deck and clean and expose reinforcing for NCC to cast on new sections of parapet.

The Conjet Robot 363 removed per day in average some 30 to 35 m of deteriorated concrete from the edge of the deck.

After Waterjet removed a length of the deck edge and exposed and cleaned the original steel reinforcement, NCC followed on casting on a new section of reinforced deck and integral parapet edge beam. NCC and Waterjet stagger these repairs from each side of the bridge to prevent the risk of any chloride cross contamination from the old concrete being removed and new concrete. In addition Waterjet is also using a pair of its earlier Conjet 230 Robots to cut out an average of 8 m³ of concrete and remove all the old reinforcing from each of the 19 joints for NCC to replace with new.

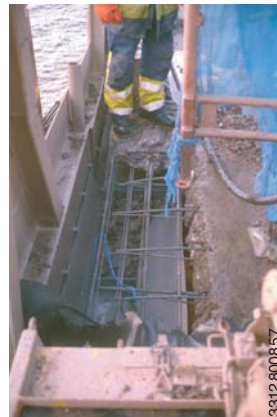
Exposed bridge deck reinforcement

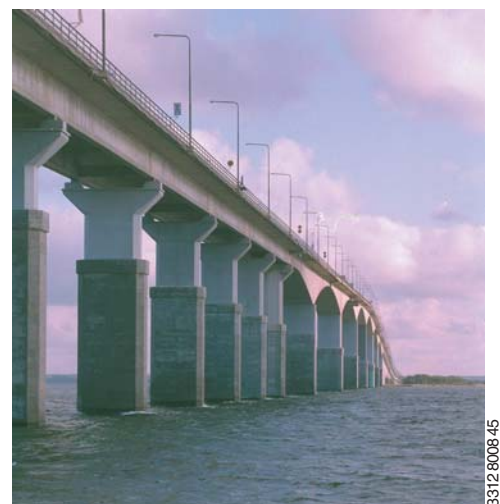
A 6 320 m long multi-span bridge.

The 6,320 m long multi-span bridge links the Swedish mainland at Kalmar with the Baltic islands of Svinö and Öland across the deep channel of Kalmar Sound. The initial 248m long reinforced concrete Svinö bridge continues directly into the similar and main 155 span Öland bridge. This consists of a 23 span low level viaduct on the mainland side, a high level eight span 910 m long structure over the 80 m wide navigable channel, followed by a further 124 low level spans to Öland island. The bridge's 13m wide single cell reinforced concrete box deck is supported at the end of each span by a single rectangular reinforced concrete pier. All piers are founded on mass unreinforced concrete slab footings, with about one third of them supported on either concrete or tubular steel piles.
